Laser-Induced Damage Threshold (LIDT) Measurement Report

ISO21254-2: S-on-1 Test Procedure

Sample: RTP 15124602003

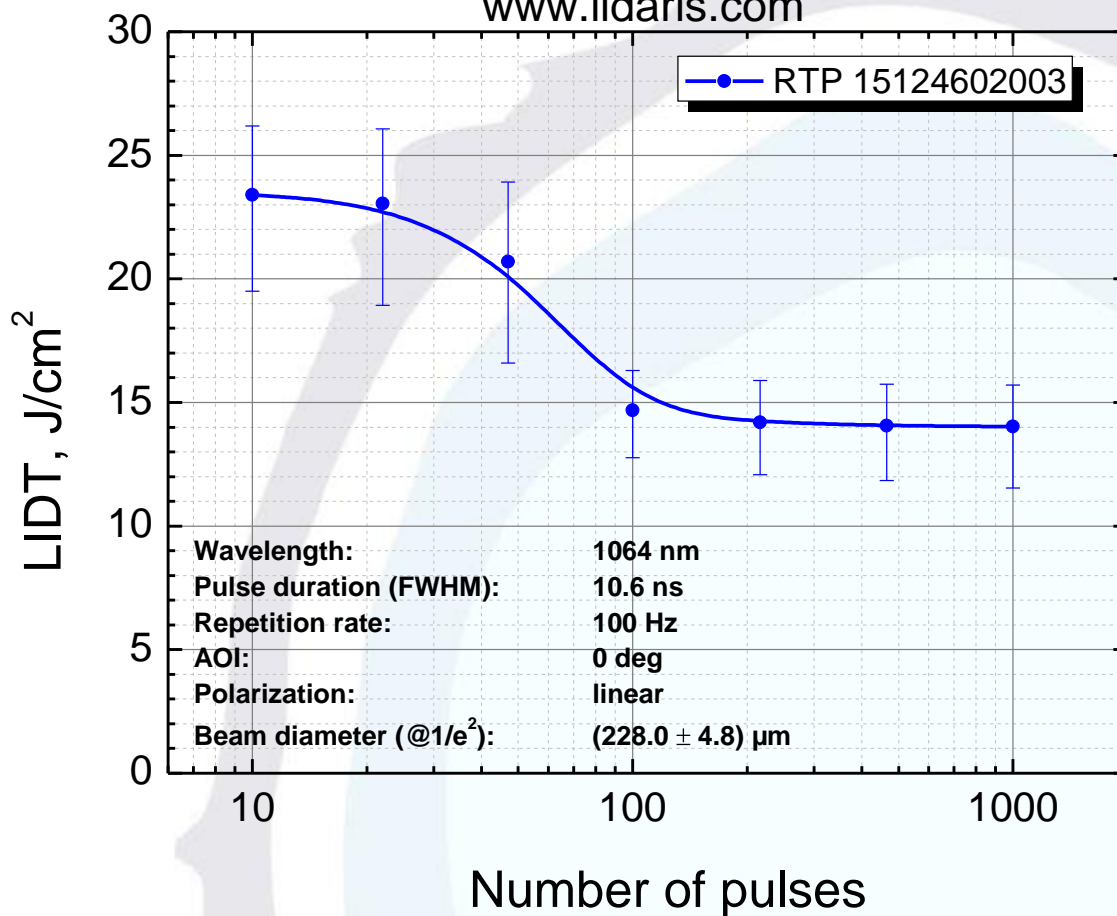
Test mode	Threshold, J/cm ²
10-on-1	19.50 ≤ 23.39 ≤ 26.18
1000-on-1	11.54 ≤ 14.02 ≤ 15.71

Fig. 2. Characteristic damage curve

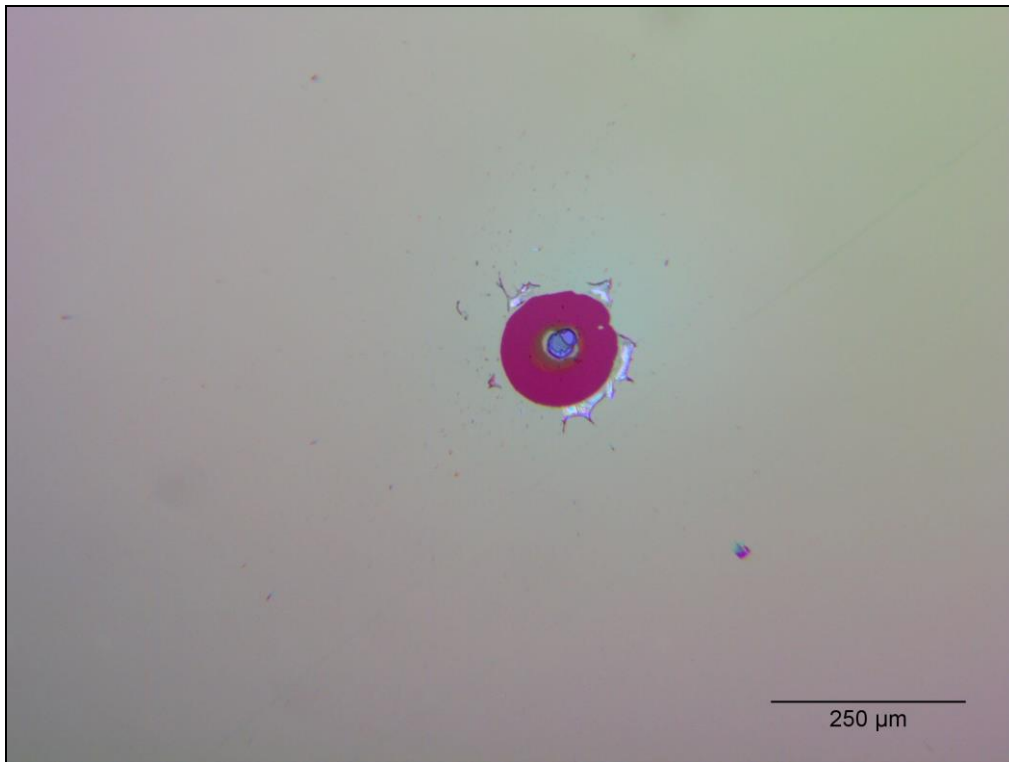
**Fig. 3. Typical front surface damage morphology
(Energy density 34.98 J/cm², damage after 11 pulses)**

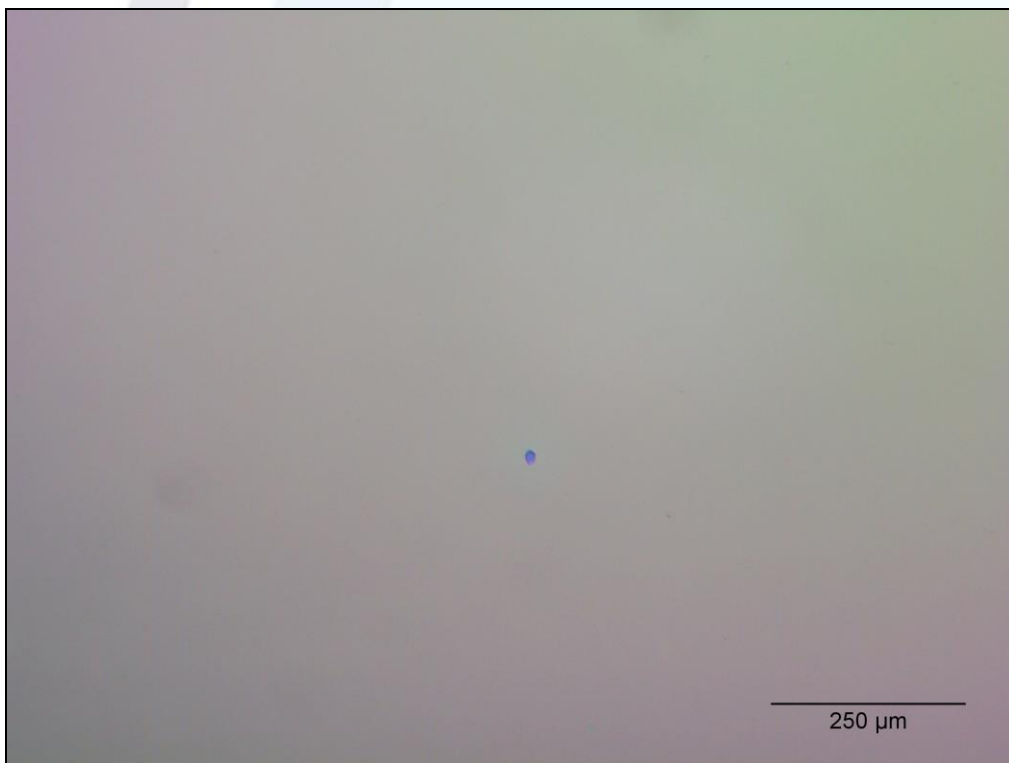
**Fig. 4. Typical front surface damage morphology
(Energy density 15.00 J/cm², damage after 1000 pulses)**
